## Products affected

Truck			Bus			Engine (I&M)		
4	PGRT	LPGRS	3	4	FKN	P93	P96	E2011
-	X	X	-	-	X	-	-	X

# XPI injectors with the same trim codes

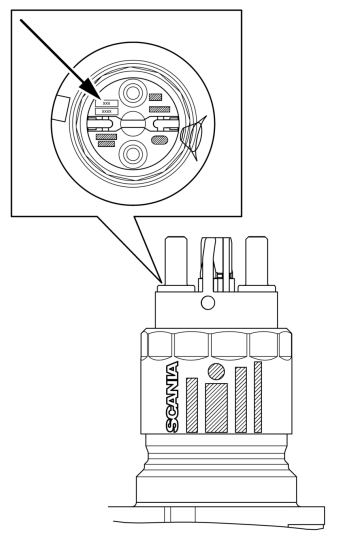
*Injector without trim code.*
